REMEDIAL ACTION PROGRAM
for
TANK REMOVAL AND THE CONTAINERIZATION of
CONTAMINATED SLUDGES AND SOILS at
SUPERIOR SOLVENTS COMPANY
ST. LOUIS, MISSOURI

March 3, 1988
REACT Project 1773.2

Prepared by
Jonathan R. Spencer
Director of Engineering
RYCKMAN'S EMERGENCY ACTION AND CONSULTING TEAM
2208 Welsch Industrial Court
St. Louis, Missouri 63146

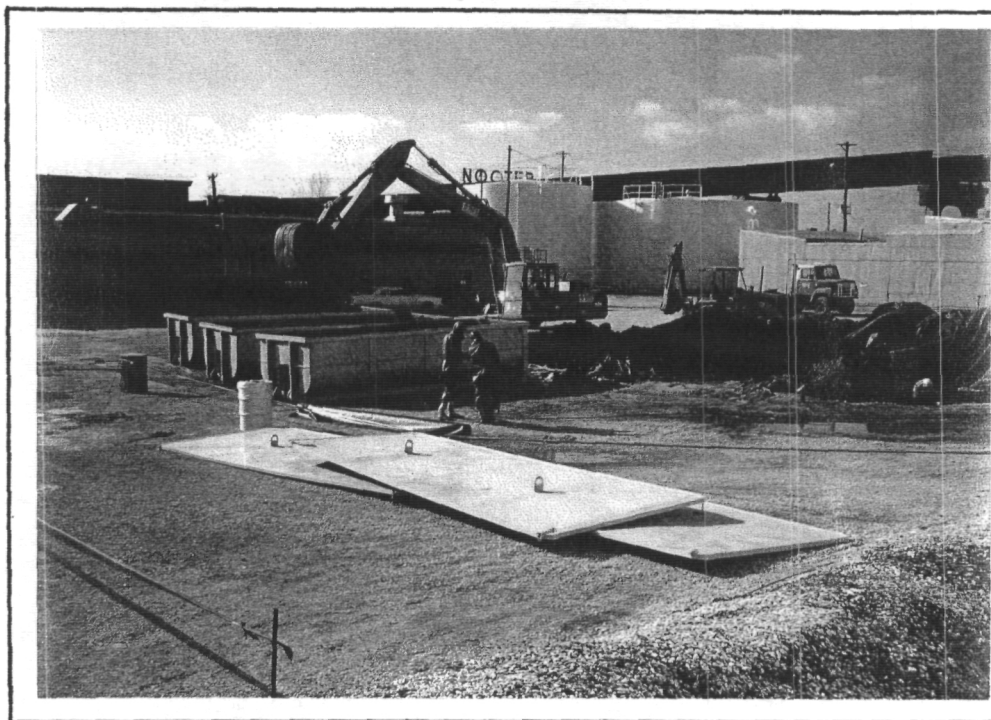
Figure 3. A track excavator was used to transfer contaminated material into roll-off containers within the exclusion zone. Note the lids which were staged in the contamination reduction zone.

The Exclusion Zone consisted of the active work area where sludge excavation and containerization of hazardous material occurred. The perimeters of this area were marked with brightly colored hazard tape as shown in Figure 3. All personnel entering the Exclusion Zone were required to wear the prescribed level of personal protective equipment. A list of each person entering this zone was recorded on a daily basis and is included on the "Daily Activities Log" which has been compiled in Appendix III.

Once each roll-off container was filled, a steel lid was placed over the container (shown in Figure 3). The roll-off was numbered and secured with two padlocks on opposite corner (Figure 14). The roll-off containers were staged in two areas at the southwest corner of the property as shown in Figures 15 and 16. The relative location of the twelve roll-off containers is shown on the schematic presented as Figure 27.

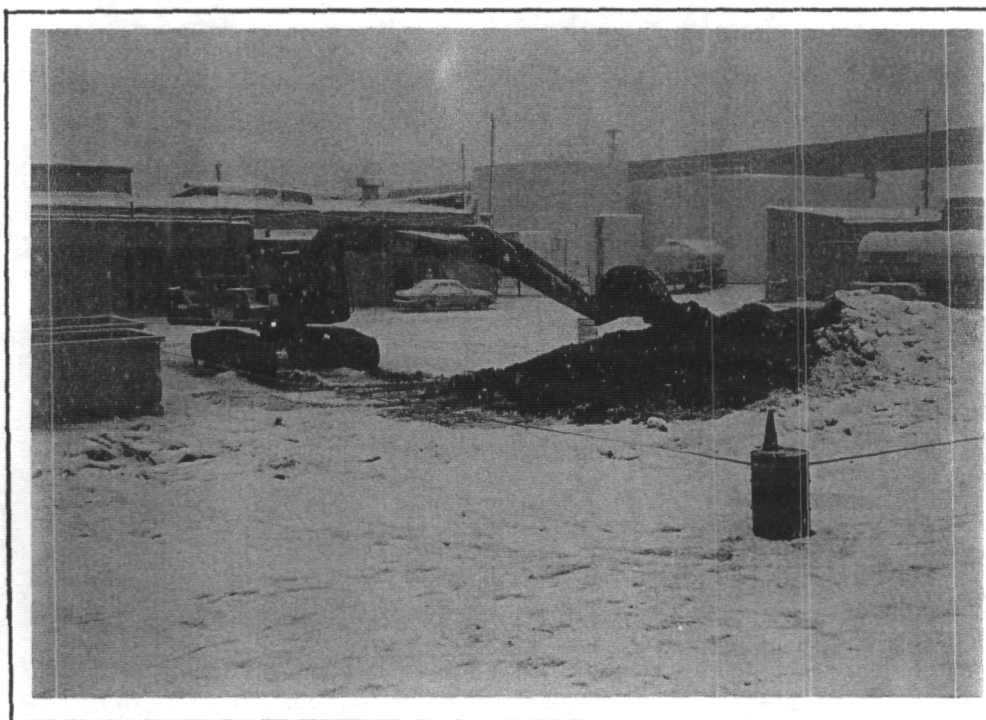
Figure 4. Loading operations continued despite severe weather conditions which were encountered near the end of the project.

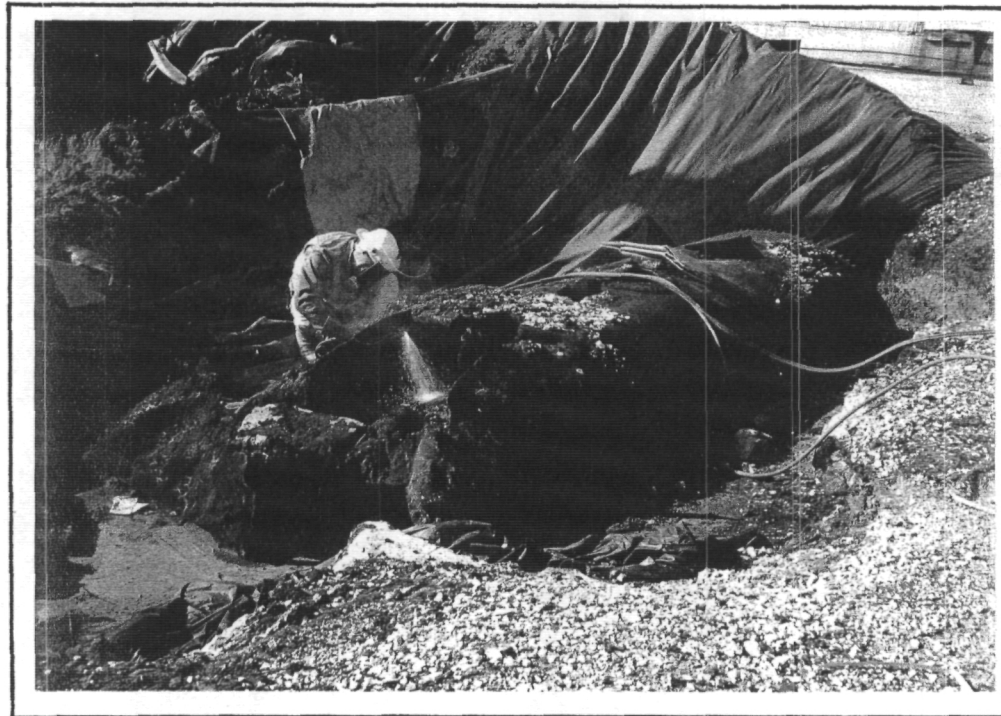
Figure 5. Personnel in level "B" protective gear used an acetylene gas torch to cut away the top of the buried tank.

The atmosphere in and around the buried tank was checked with a MSA Model 2A Explosiometer prior to initiating work on the tank itself. No explosive vapors were detected (0% LEL). Personnel in level "B" protective gear then proceeded to cut away the top of the tank using an acetylene gas torch (Figure 5). Once the top of the tank had been completely cut away, the track excavator was used to place it into one of the adjacent roll-off containers (Figure 6).

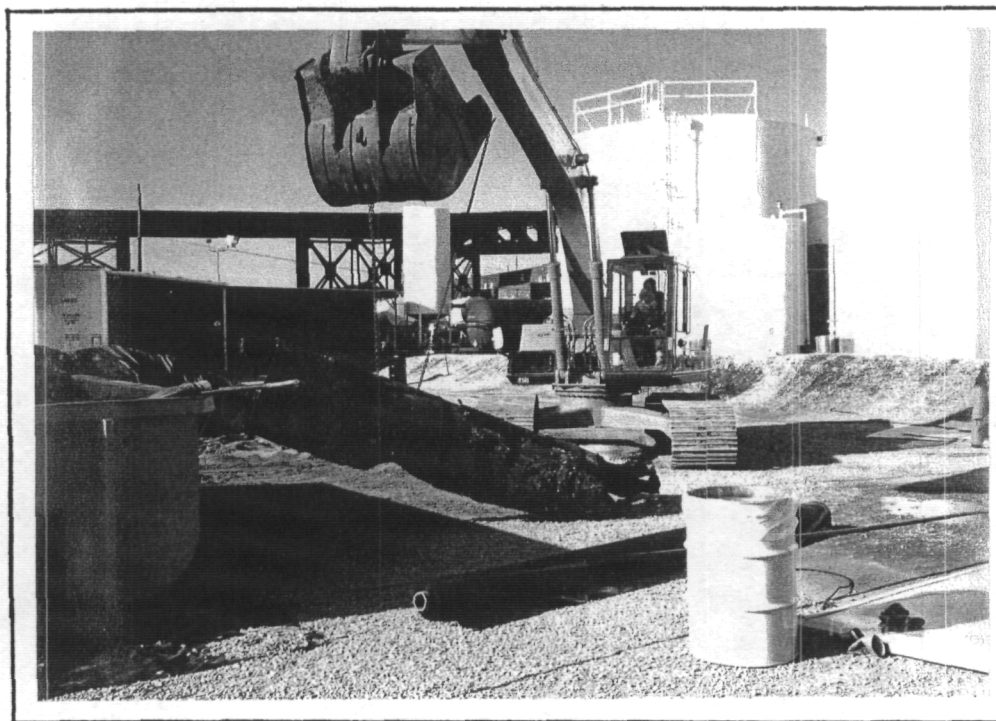
Figure 6. The track excavator was used to transfer the top of the tank into a roll-off container.

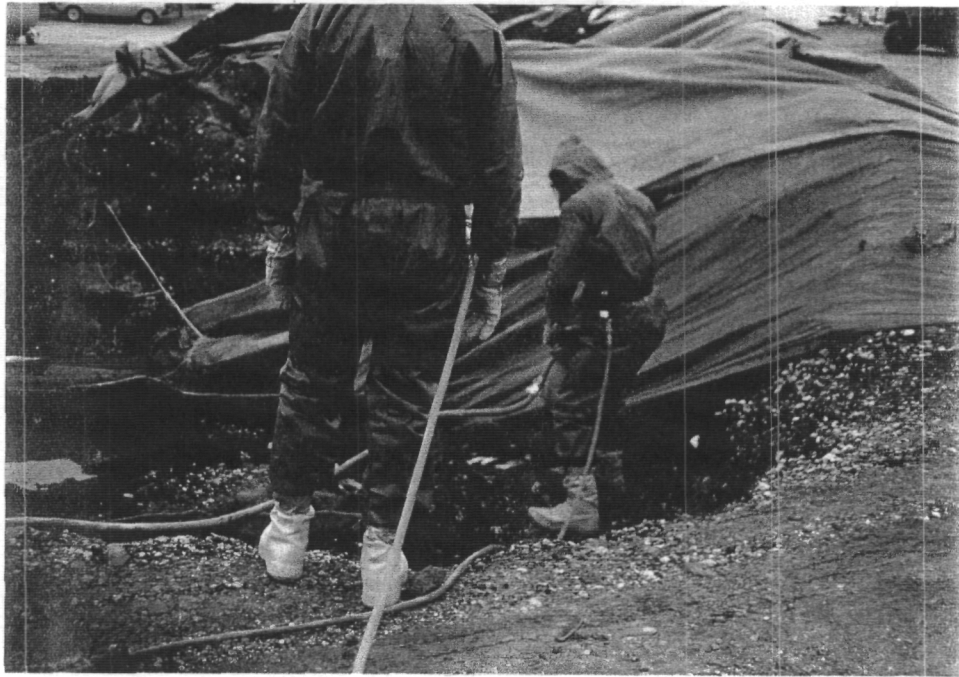
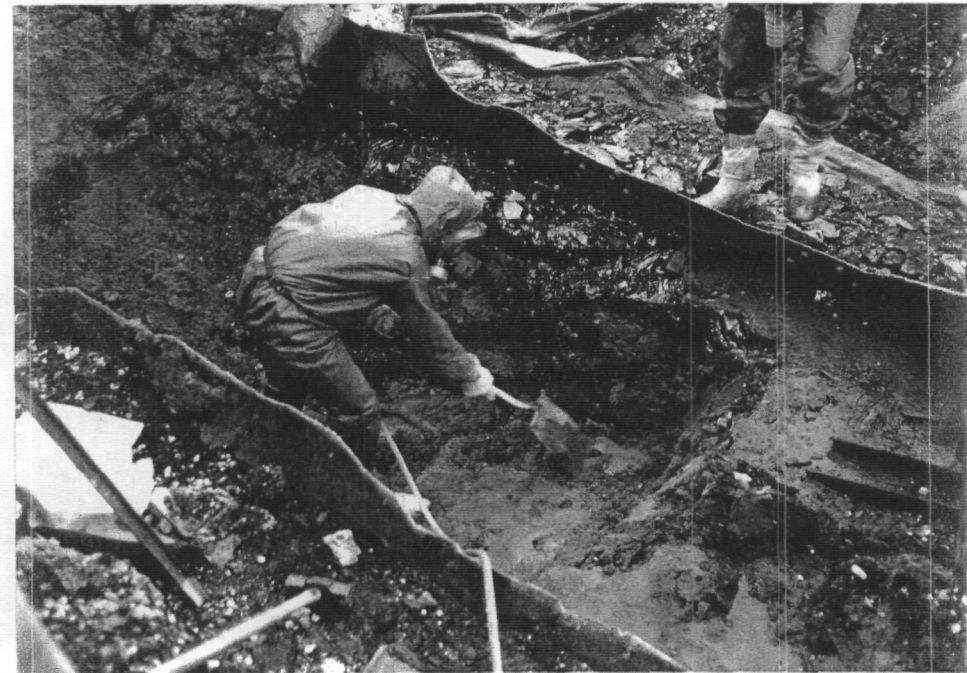
Figure 7 (above) and Figure 8 (below). Personnel in level "B" protective gear used air hammers and shovels to loosen sludges inside of the tank prior to bulk removal.

Personnel in level "B" protective gear used an air-hammer and shovel to loosen a portion of the solidified sludges in and around the buried tank as shown in Figures 7 and 8. Once the material was loosened, the track excavator was then used to transfer the bulk sludges into an adjacent roll-off container (Figure 9).

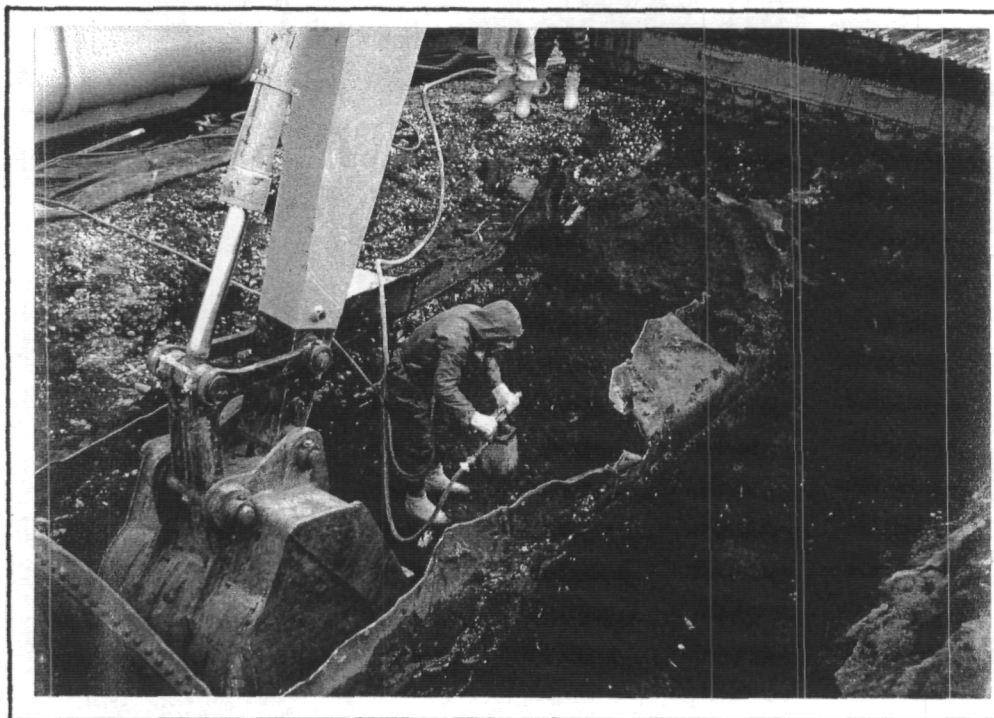
Figure 9. The track excavator was used to accomplish bulk removal of sludges within the buried tank.

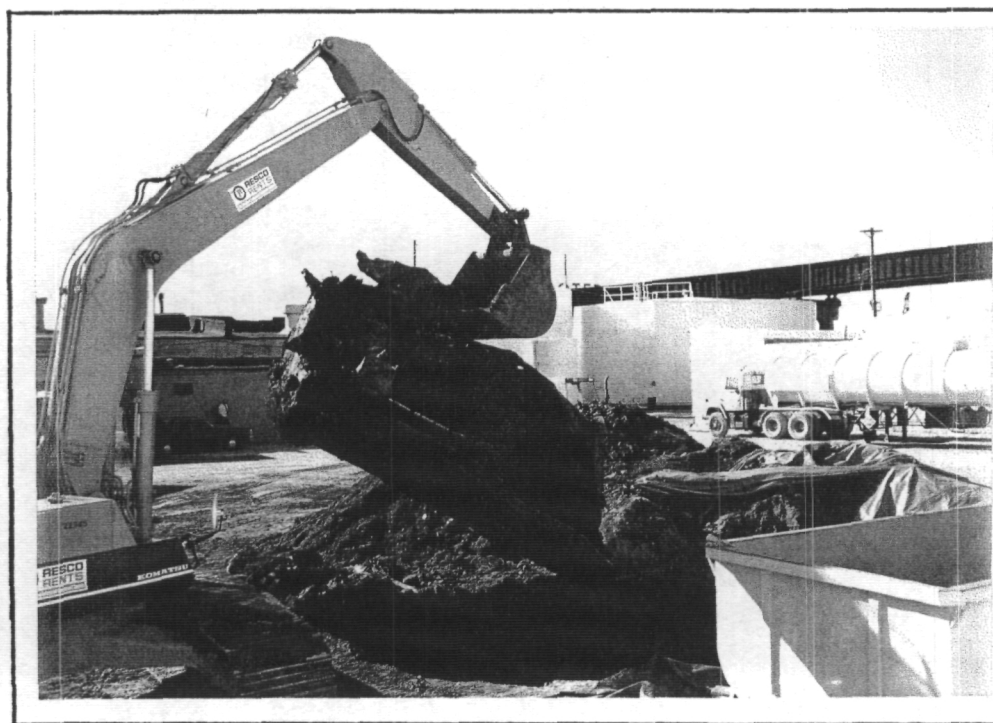
Figure 10. Once the sludges had been removed, the buried tank was able to be excavated.

Once the sludges had been removed from in and around the tank, an inspection was made by personnel in level "B" protective gear to verify that no direct connection existed between the tank and the underlying Mill Creek sewer line. The track excavator was then used to lift out the empty tank as shown in Figures 10 and 11. Personnel working in level "B" protective gear used an acetylene gas torch to cut up the tank so that it could be placed in one of the steel roll-off containers (Figure 12).

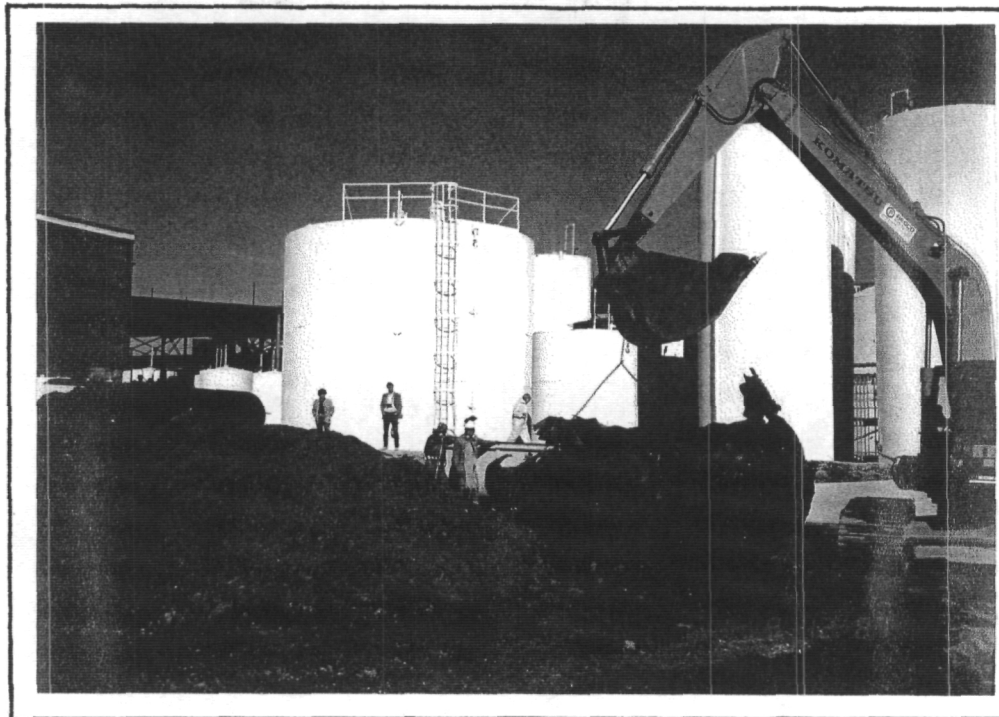
Figure 11. The buried tank after removal.

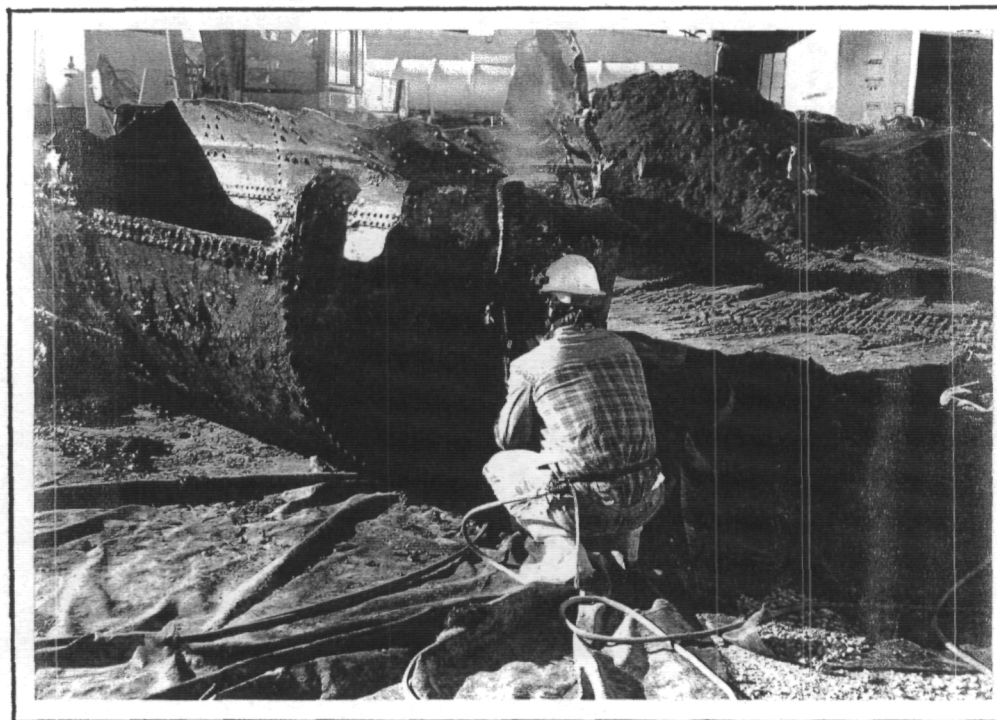
Figure 12. Personnel in level "B" protective gear used an acetylene gas torch to cut up the tank for subsequent containerization.

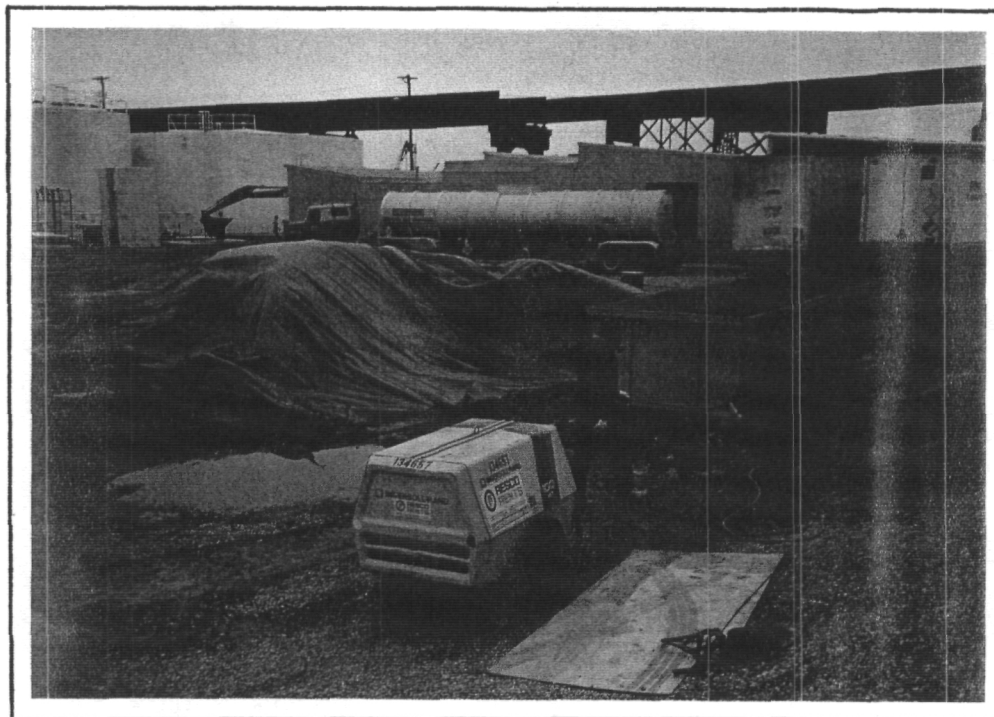
Figure 13. Plastic sheeting was used to keep the pile dry and to prevent contaminated runoff from entering the excavation.

At the end of each day, the excavation and soil pile was covered with 6-mil plastic sheeting as shown in Figure 13 to keep the pile dry and to prevent contaminant run-off from entering the excavation. Roll-off containers were delivered to the site and staged in the exclusion zone on an as-needed basis. The track excavator was used to transfer soil from the pile into the roll-off containers.

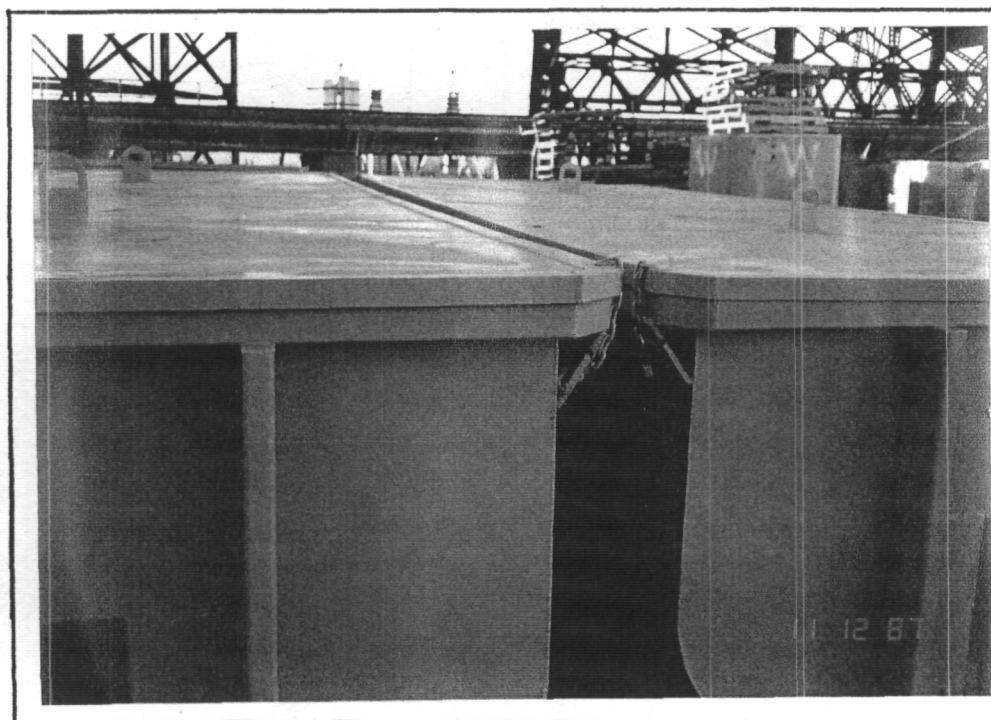
Figure 14. Each roll-off container was numbered and locked before being stored on-site.

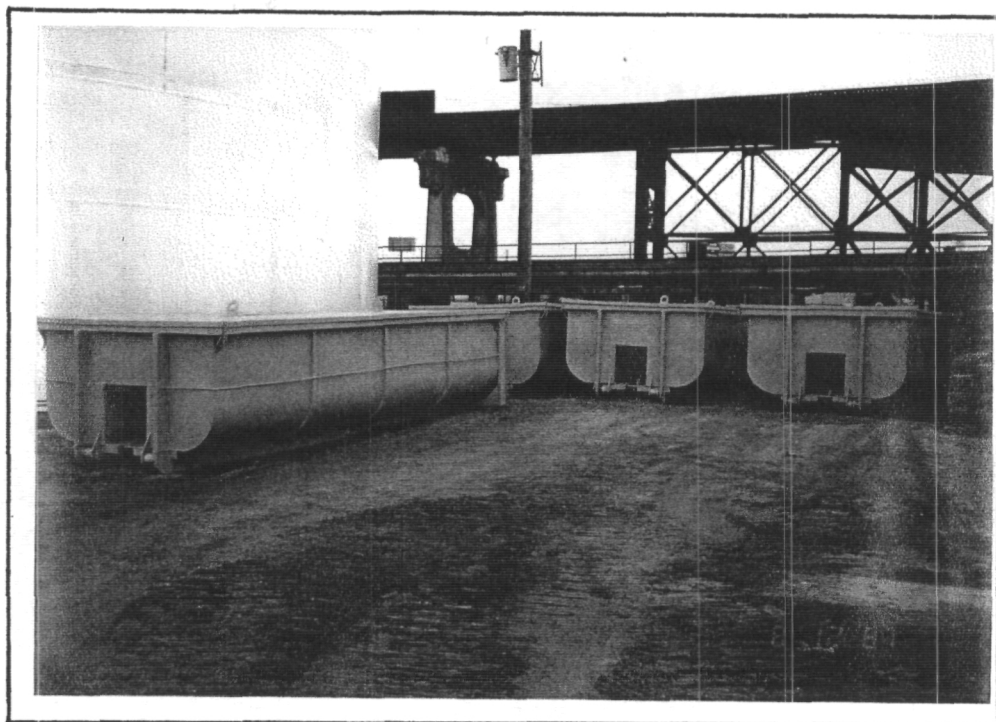
Figure 15. A view of roll-offs 1, 2, 3, and 4 which were staged on the southwest corner of the property for on-site storage.

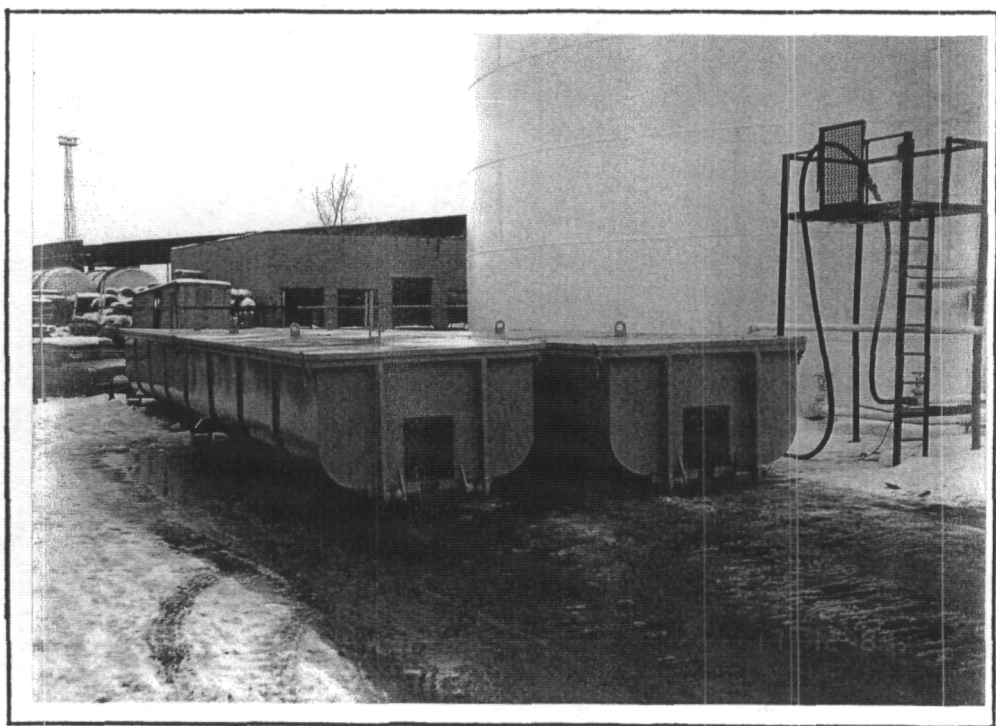
Figure 16. Roll-offs 7, 8, 9, and 10.

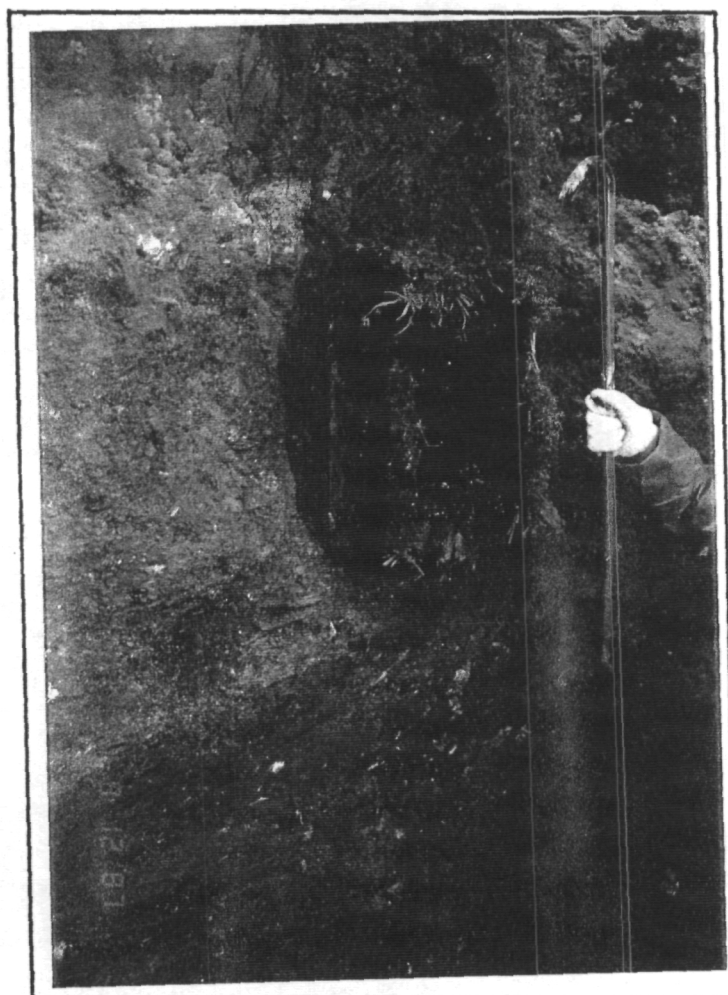
Figure 17. The wooden conduit located on the south wall of the excavation which was discovered while removing contaminated soils.

During the excavation process, a wooden conduit was uncovered on the south wall of the excavation. The conduit measured approximately twelve inches high by eight inches wide (see Figure 17) and appeared to be filled with a black viscous, tar-like material, not unlike what had been removed from the buried tank. There was no evidence of a direct connection between the conduit and the tank. EPA was promptly notified of this development and sent their project manager (Ms. Pauletta France-Isetts) out to the project site in order to inspect the conduit and provide further recommendations.

REACT personnel in level "C" protective gear collected and split samples of the material from within the conduit with EPA's on-scene coordinator. After the EPA inspection, the location of the conduit was tied into four reference points on the site. Each of these four reference points is provided as Figure 28.

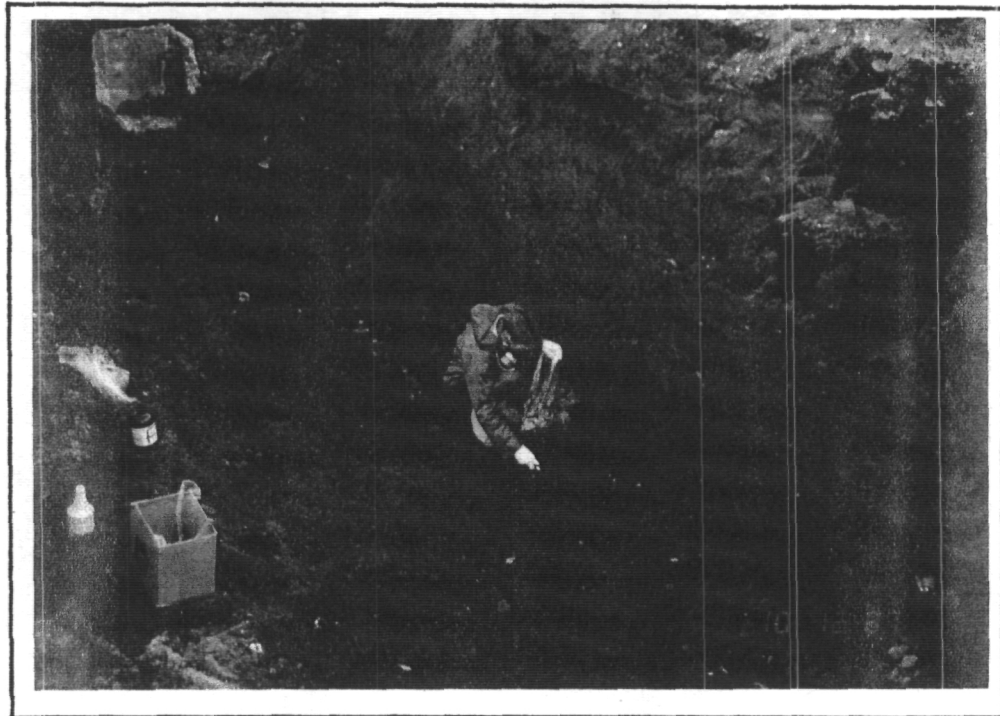
Figure 18. Collection of performance samples from the bottom of the excavation. Note the wooden conduit on the south wall.

Once all of the visibly contaminated soils had been removed from the excavation, four discrete soil samples were collected from the bottom surface (Figure 18). Two of these samples (#E-1 and #E-2) were taken from depths of 8'0" and 8'4" north of the excavation centerline. The remaining two samples (E-3 and E-4) were "deep" samples taken south of the excavation centerline at depths of 8'10" and 9'8", respectively. The relative location of these four sampling points are shown in Figure 29. In each case, samples were collected by personnel in level "C" protective gear using a stainless steel trowel which had been decontaminated with a soap and water wash, deionized water rinse, acetone rinse, and a final rinse with deionized water. Soil samples were placed in laboratory cleaned glass jars (I-Chem Lot #10208713) and packed in individual paint cans for shipment to the laboratory. The sample transmittal form and chain-of-custody record is attached as Appendix IV. All four samples were analyzed for 2, 3, 7, 8-TCDD, B/N/A's, and total phenols. In addition, samples #E-2 and #E-4 were also run for volatile organics. A copy of the laboratory results is presented in Appendix I.

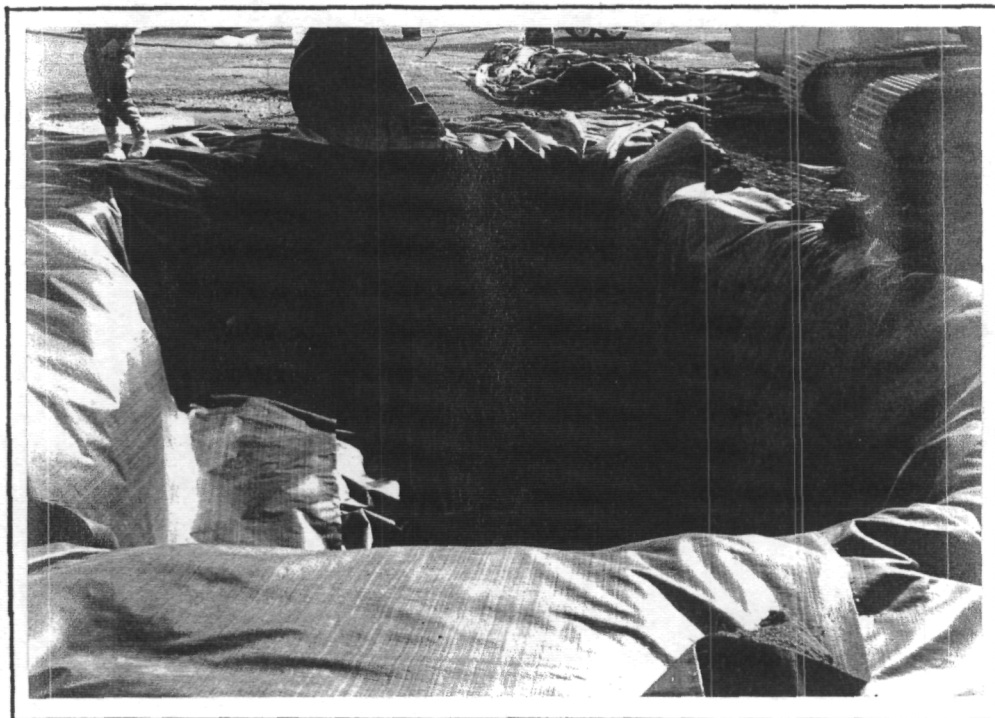
Figure 19. The excavation was lined with Amoco 2002 geofabric prior to being backfilled.

After the performance samples had been collected, the excavation was lined with Amoco 2002, a permeable geofabric, as shown in Figure 19. Two truckloads of clean sand were used to backfill the excavation (Figure 20) and the sand was then covered with a truckload of clay to reduce water percolation rates through the soil column. The track excavator was used to compact this material after each load. Once the hole had been completely backfilled, seventy-two tons of one-inch minus gravel were used to restore the work area and allow for subsequent truck traffic over the disturbed area. A Cat 426 front-end loader was used to spread the gravel as required.

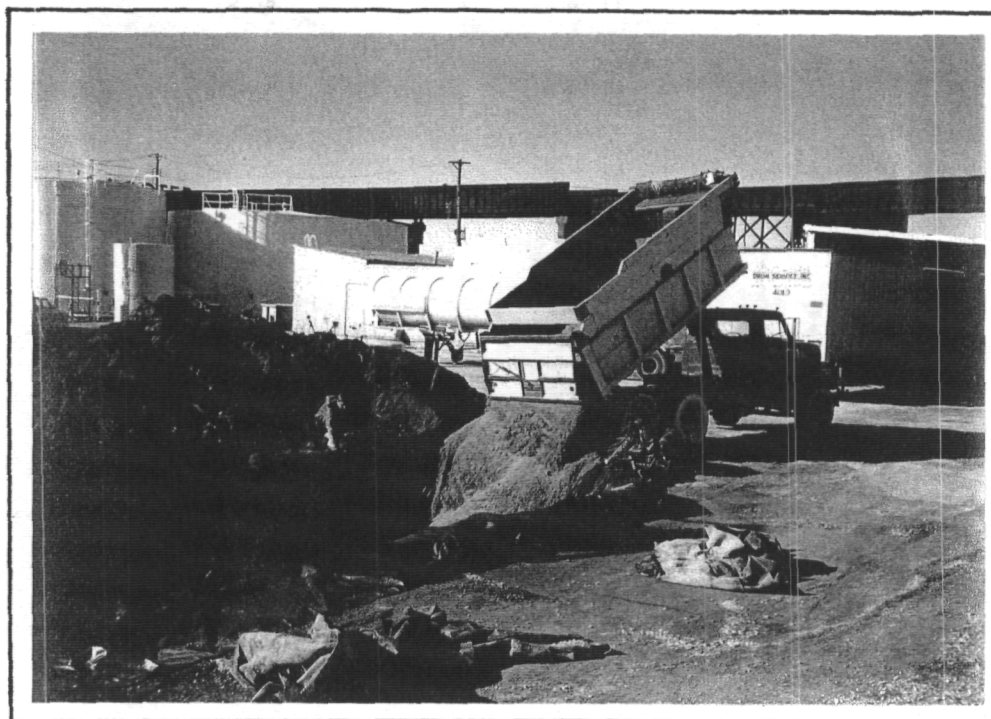
Figure 20. Clean sand and clay was used to backfill the excavation.

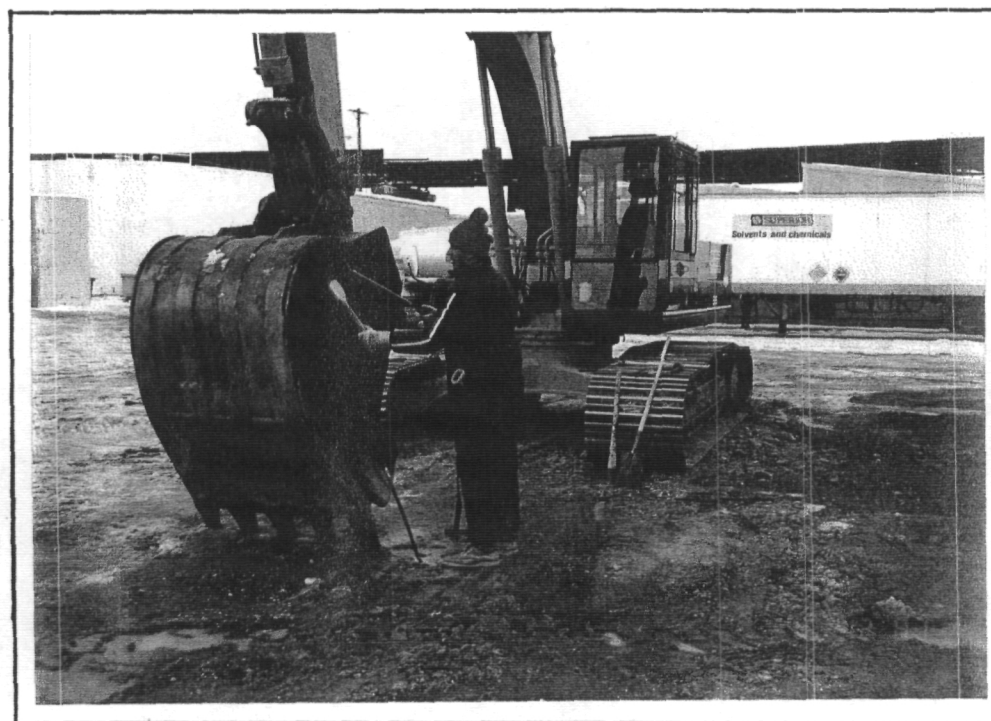
Figure 21. The excavator bucket was decontaminated using a soap and water solution followed by an acetone rinse.

The track excavator, backhoe, and all recoverable equipment were decontaminated prior to their demobilization off site. The buckets which had been used to move contaminated soils and/or sludges were cleaned using a soap and water solution (Figure 21), followed by an acetone rinse. A picture of the front-end loader after decontamination is shown in Figure 22.

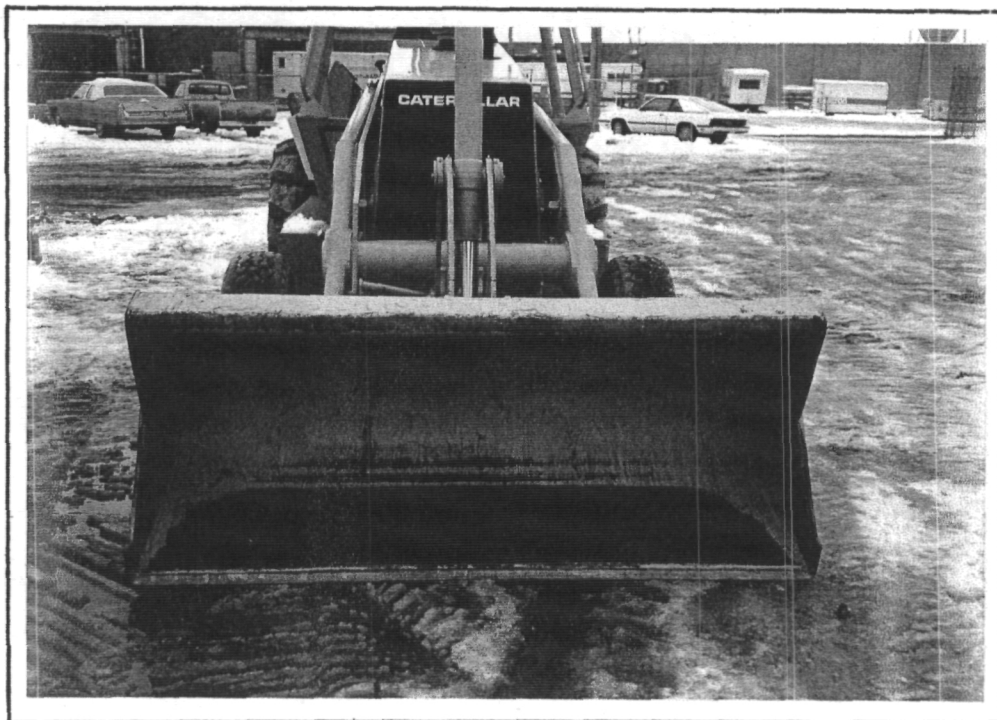
Figure 22. The front-end loader after decontamination.

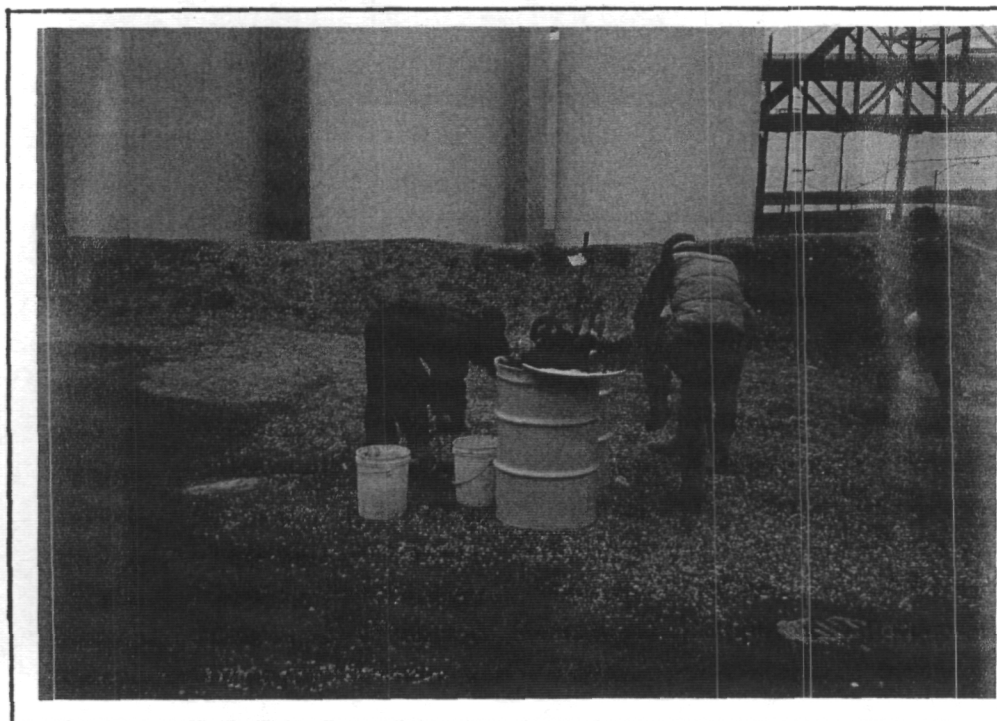
Figure 23. Disposal of personal protective equipment took place in the contamination reduction zone.

Decontamination of work tools and doffing of personal protective gear was accomplished on a daily basis, as required. All personnel inside the exclusion zone were required to pass through the contamination reduction zone where disposable protective equipment was removed and containerized (Figure 23). All contaminated clothing and equipment, including Tyvek suits, boot covers, gloves, and respirator cartridges were bagged and placed in the roll-off containers for on-site storage.

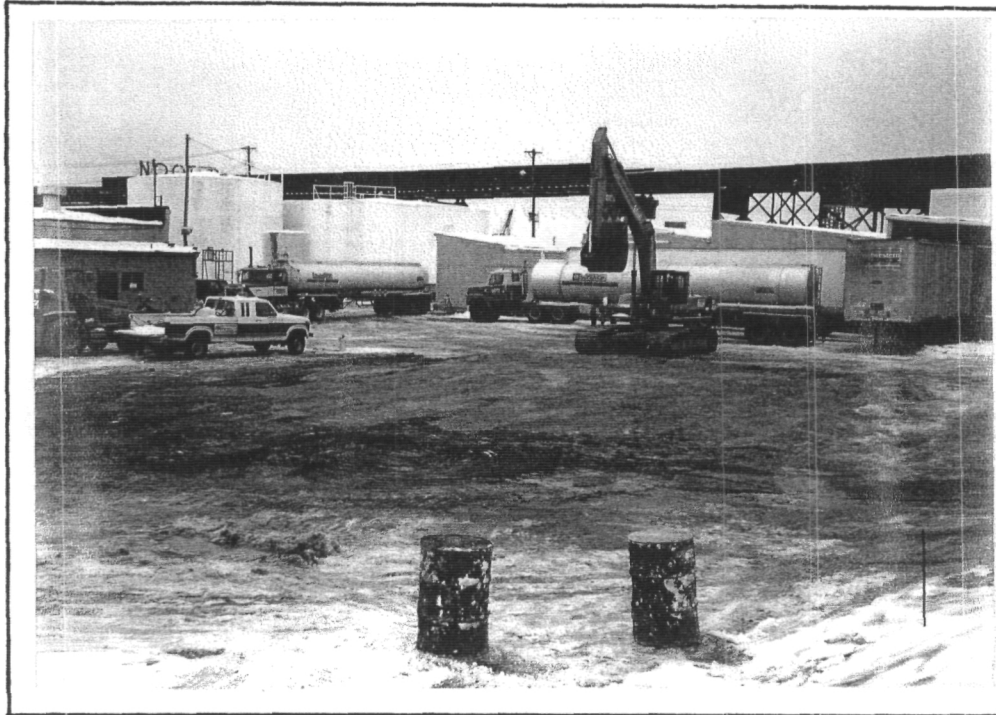
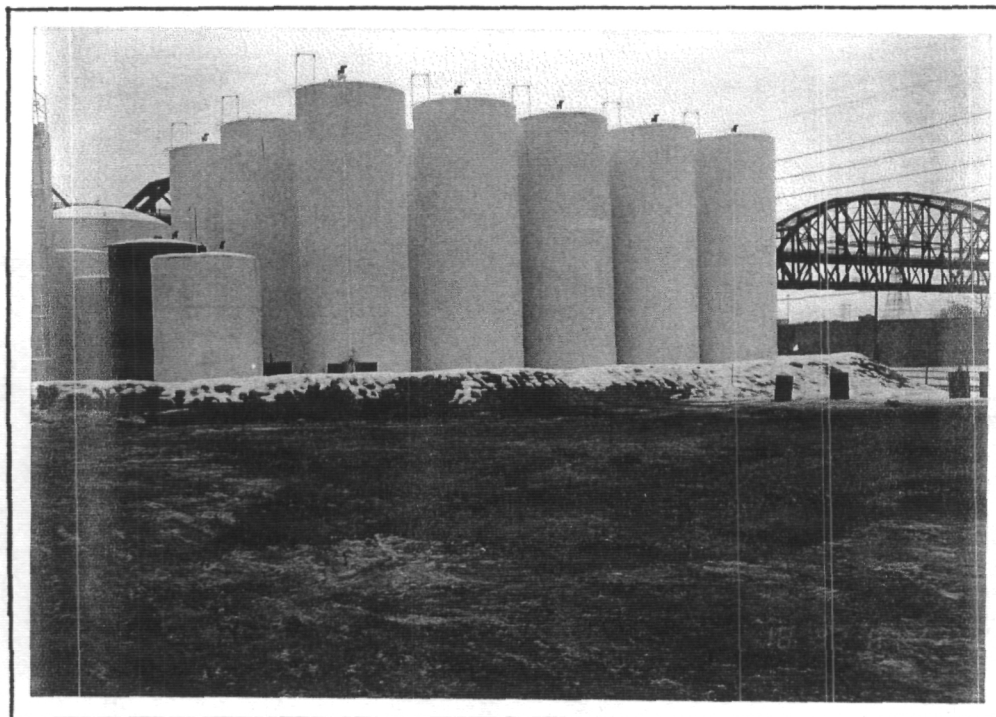
Figure 24 (above) and Figure 25 (below). A view of the work site after restoration activities had been completed. Note clean gravel which was placed over the area to allow for unrestricted truck traffic.

Once all on site work activities had been completed and all materials had been decontaminated, personnel and equipment were demobilized from the site. Figures 24 and 25 show the work area on-site after site restoration activities had been completed.

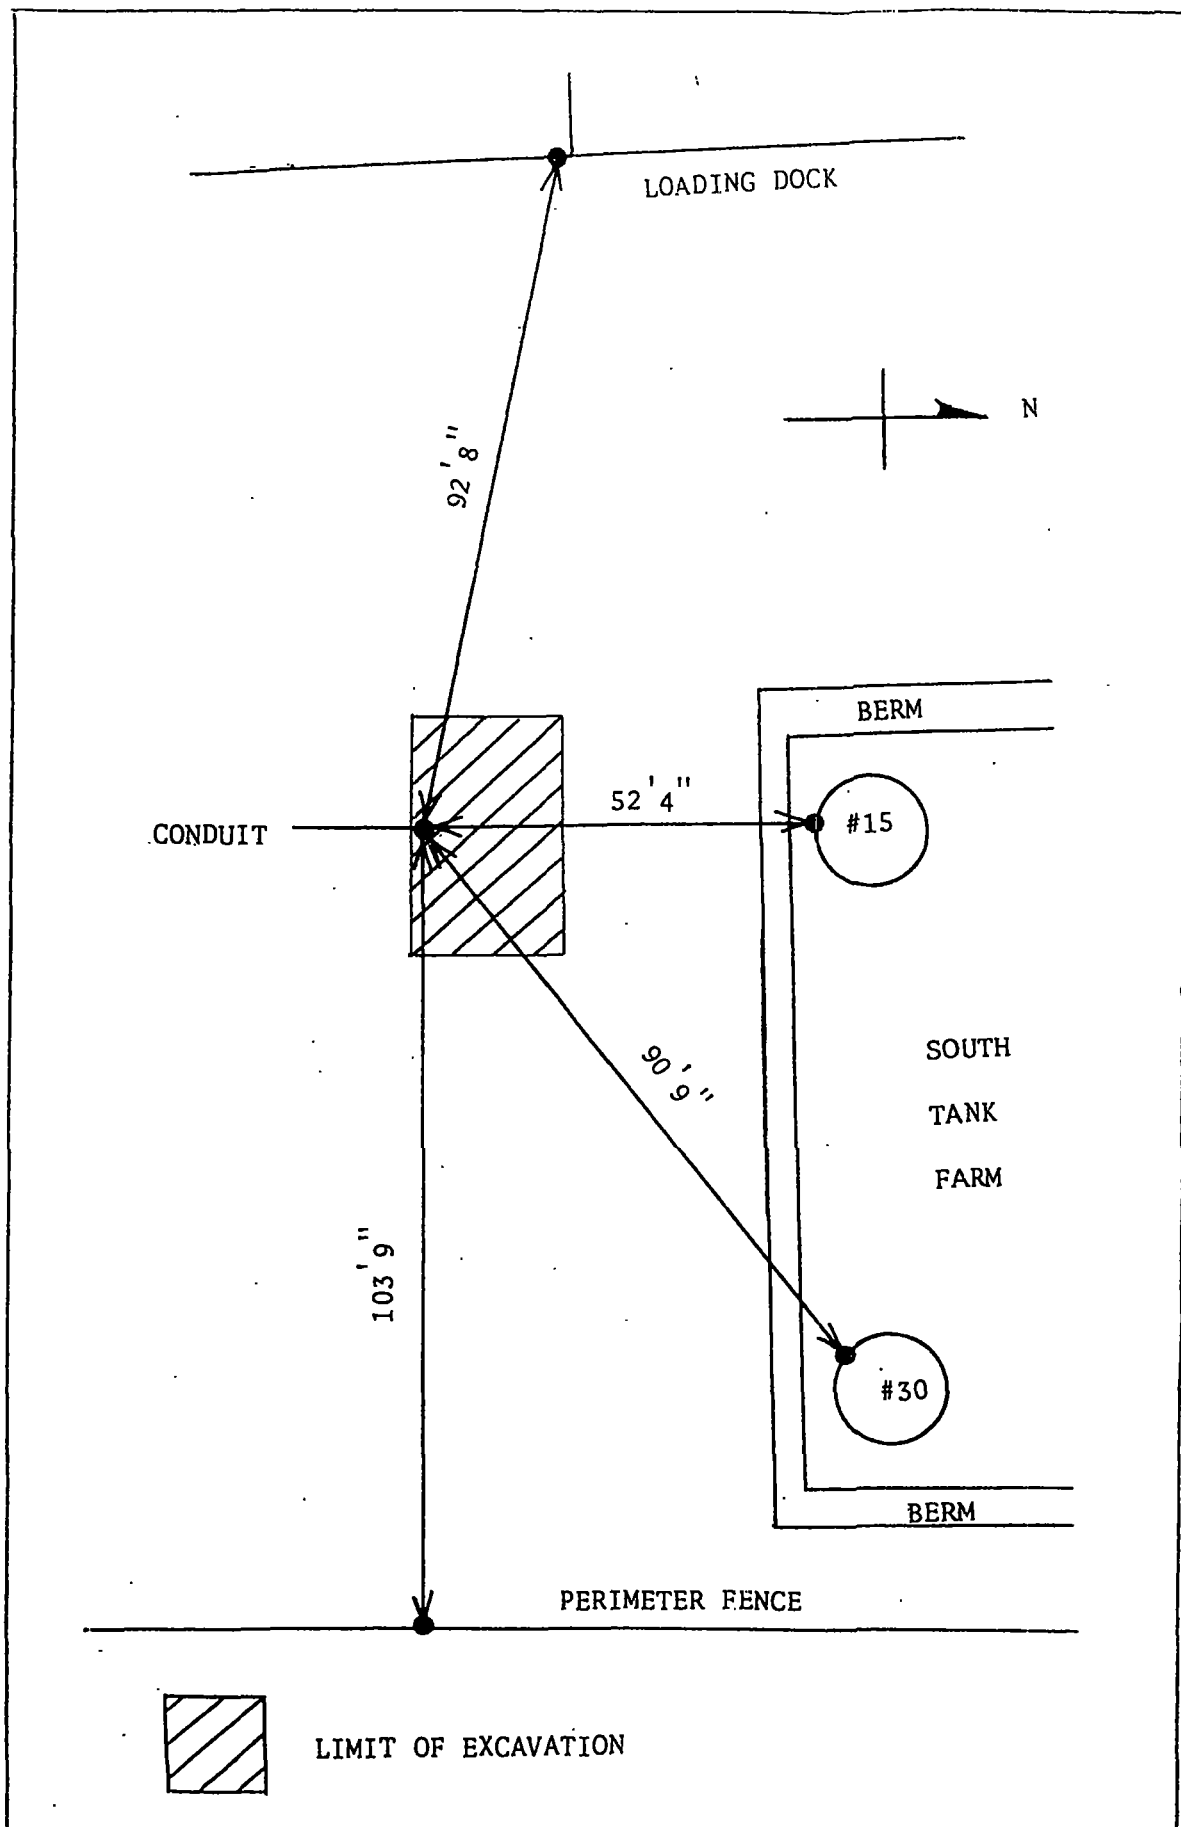
Figure 28. Schematic showing location of the conduit discovered during excavation of the buried tank.
